Propeller Owner's Manual & Log Book

F.A.A. Approved
Manual No. 115N
Revision 2
May 1992

All "Compact" Models

Series: ()HC — ()(2, 3, 4)Y() — (1, 2, 4, 5, 7)()

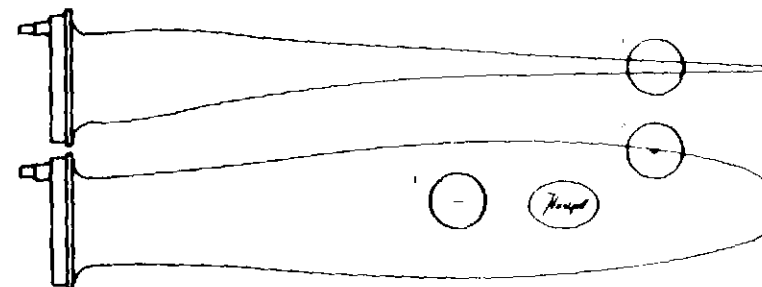
Small nicks and gouges are just as detrimental as large ones. Repairs must be made immediately to prevent propeller failure.

TO DETERMINE THE NEEDED AMOUNT OF REWORK, USE THE FOLLOWING FORMULA
• LEADING AND TRAILING EDGE DEPTH OF NICK x 10
• FACE AND CAMBER DEPTH OF NICK x 20
NOTE: LOCAL WIDTH OR THICKNESS REPAIR DEPTH MAY NOT EXCEED THE MANUFACTURERS MINIMUM REPAIR TOLERANCE.
